Test Report

No. 14-003899-PR01
(PB-E01-02-en-01)

Order Test of resistance to wind load under dynamic
wind load

Object Roller shutter with built-in box, inspection from inside and
foamed aluminium laths

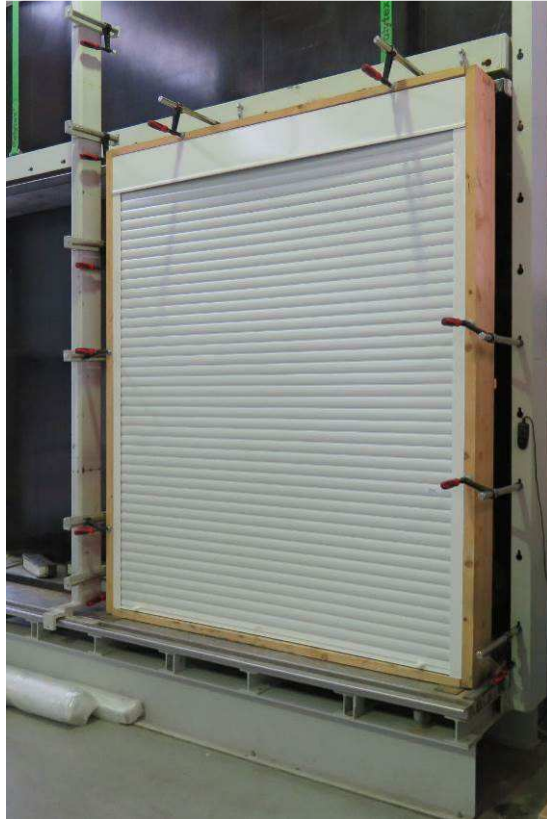
Figure 9 Test wall

Figures 9 to 12 show the schematic test arrangement and the measurement points.

The test specimen was exposed to dynamic wind load provided by two wind generators (rotor diameter \varnothing 1 m) arranged one above the other. The wind load was adjusted by setting the speed of the wind generators to different wind velocities, see Table 1.

The wind speeds generated were measured approx. 1.0 m respectively approx. 2.33 m above ground using a vane anemometer located at a distance of 1 m in front of the test specimen. The distance between the wind generators and the test specimen was 4.0 m.
