Test Report

No. 14-003899-PR04
(PB-E01-02-en-01)

Object Roller shutter with built-in box, inspection from inside and
foamed aluminium laths

Type: RS POL839

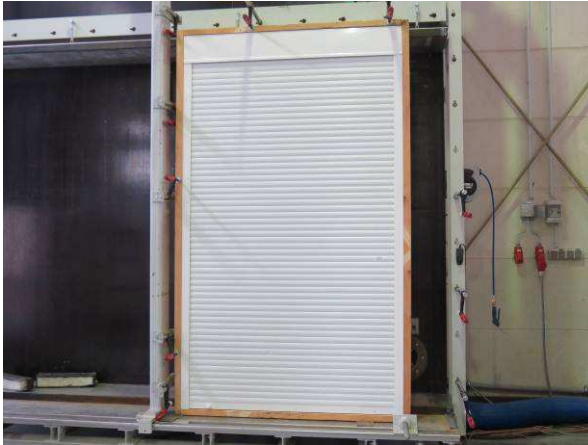
Figure 3 Test specimen

Manufacturer	ROLKA A.B.E.E.
Designation	RS POL839
	built-in roller shutter with manual operation
Element size (W X H)	1,400 mm x 2,400 mm
Slatted roller blind housing	
Material	aluminium, white coated
Dimensions (D x H)	182 mm x 182 mm
Inspection opening	inside at front
Shutter curtains	
Material	aluminium, white coated, PU foamed

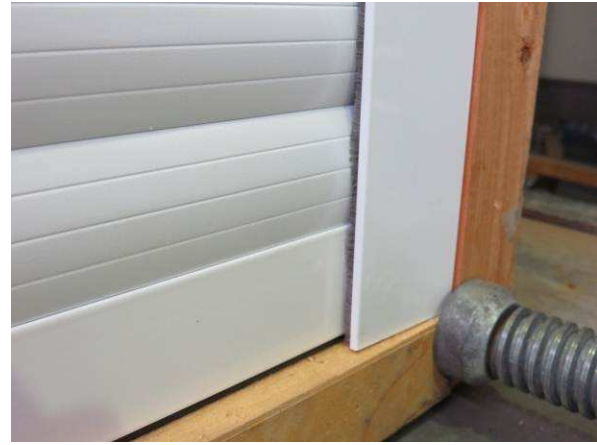
Figure 4 Bottom lath and guide rail

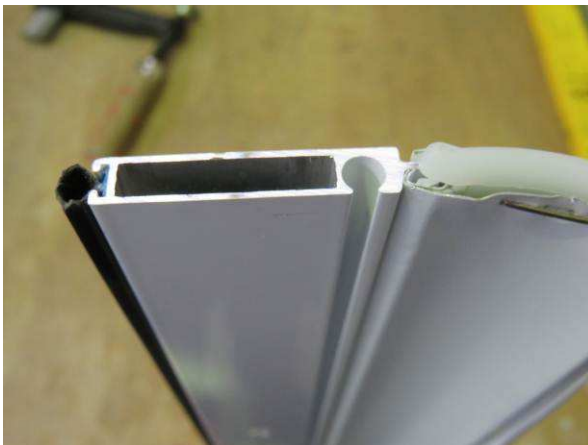
Figure 5 Detail bottom lath

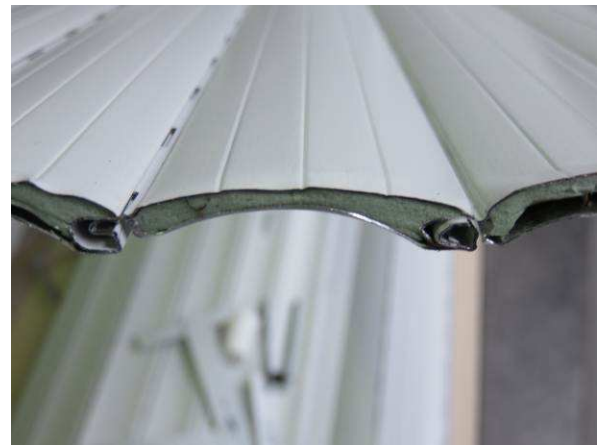
Figure 6 Details of lath profile

Item No.	lath: 8-939
	bottom lath: KAT - 001 with gasket IXO - 000
Wall thickness	0.20 mm
Number of bars	56, on sides secured against displacement
Profile cross section (W x T)	lath: 44,5 mm x 8 mm
	bottom lath: 45 mm x 7 mm
Edge cover of curtain in guide grooves	2 x 20.5 mm
Clearance of curtain in guide grooves	2 x 6.2 mm
Dimensions	
Lath width	1326 mm
Visible size of curtain (W x H)	1,296 mm x 2,200 mm
Guide rail	53 mm x 22 mm
Material	aluminium, white coated

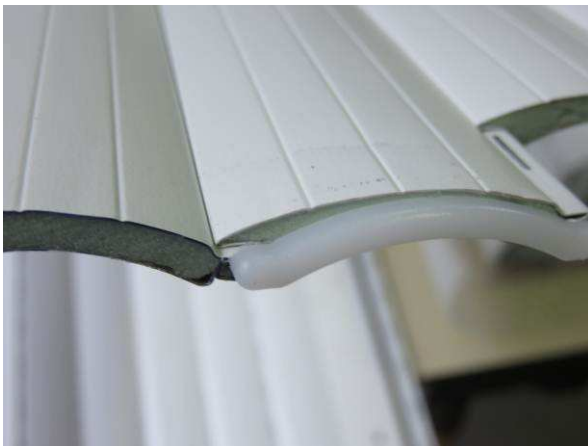
Figure 7 Details of lath profile with slider

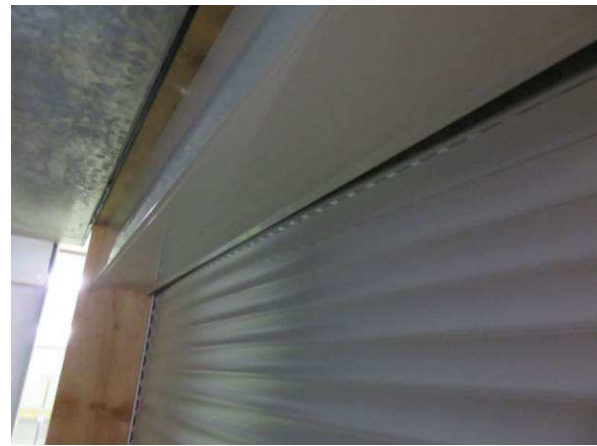
Figure 8 Roller shutter box

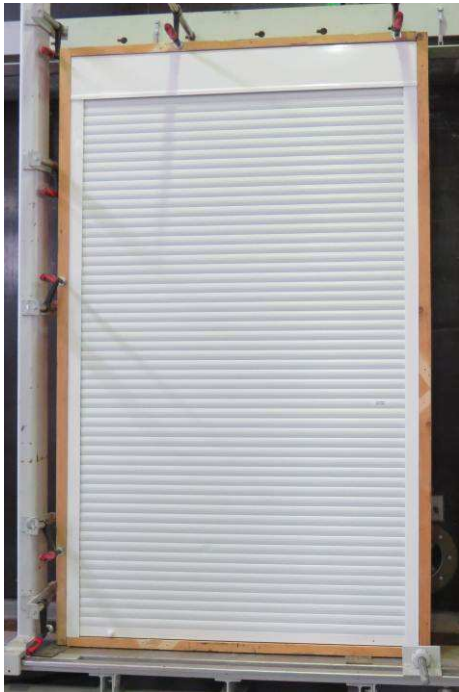
Figures 9 to 12 show the schematic test arrangement and the measurement points.

Figure 9 Test wall

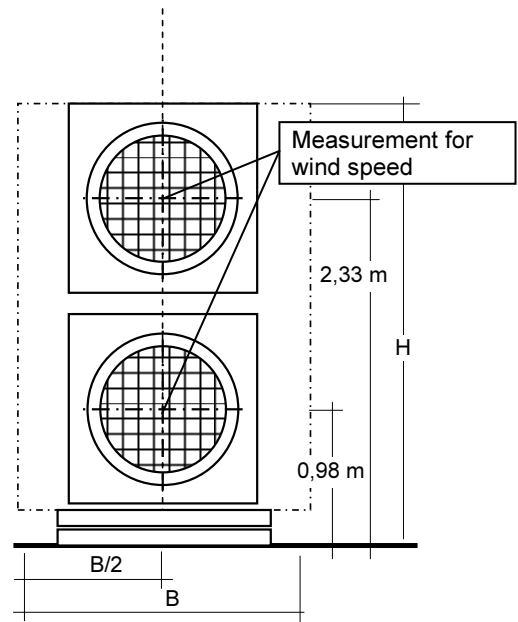
The wind speeds generated were measured approx. 1.0 m respectively approx. 2.33 m above ground using a vane anemometer located at a distance of 1 m in front of the test specimen. The distance between the wind generators and the test specimen was 4.0 m.

Figure 10 Position of wind generators

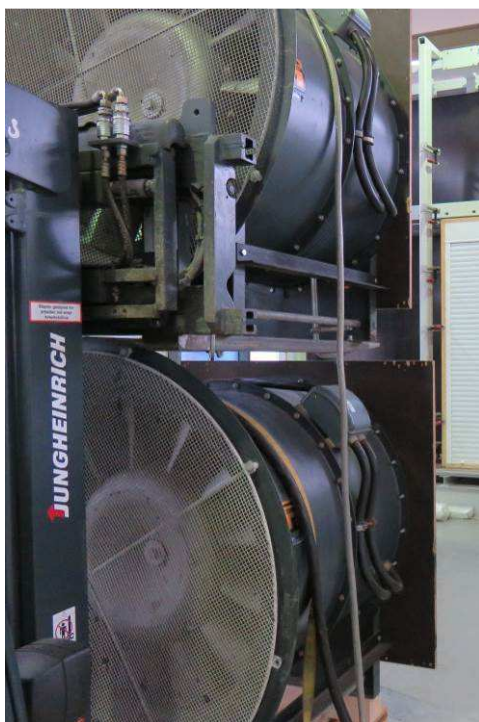
The test specimen was exposed to dynamic wind load provided by two wind generators (rotor diameter \varnothing 1 m) arranged one above the other. The wind load was adjusted by setting the speed of the wind generators to different wind velocities, see Table 1.

Figure 11 Layout of wind generators

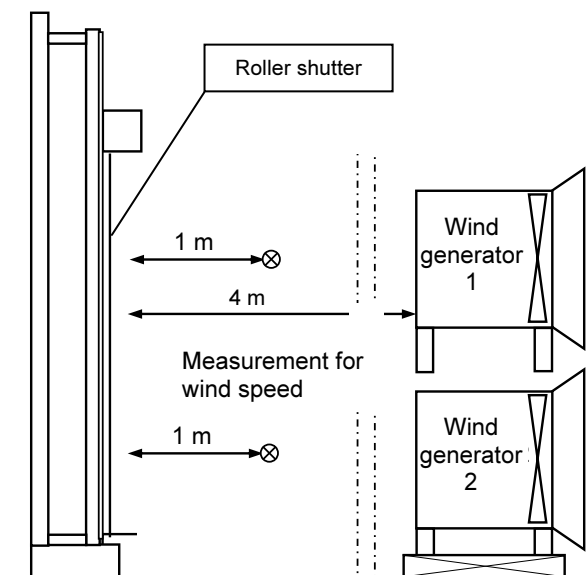
Figure 12 Test configuration for dynamic wind load
