# Test Report

No. 14-003899-PR02  
(PB-E01-02-en-01)

**Order** Test of resistance to wind load under dynamic  
wind load

**Object** Roller shutter with built-in box, inspection from inside and  
foamed aluminium laths

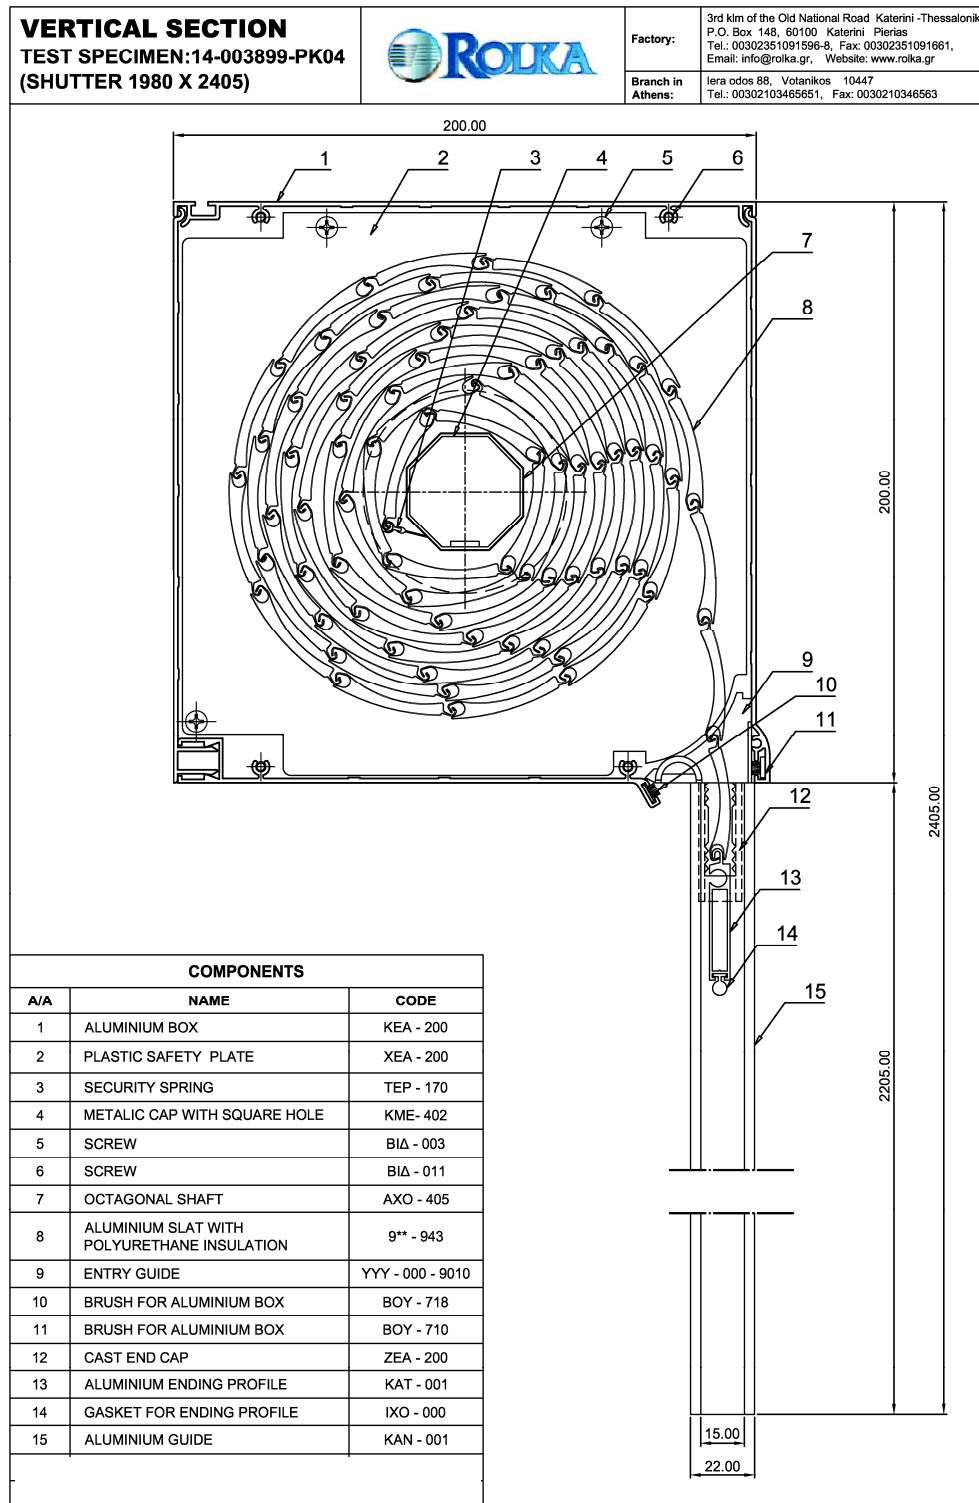
**Figure 1** Vertical section

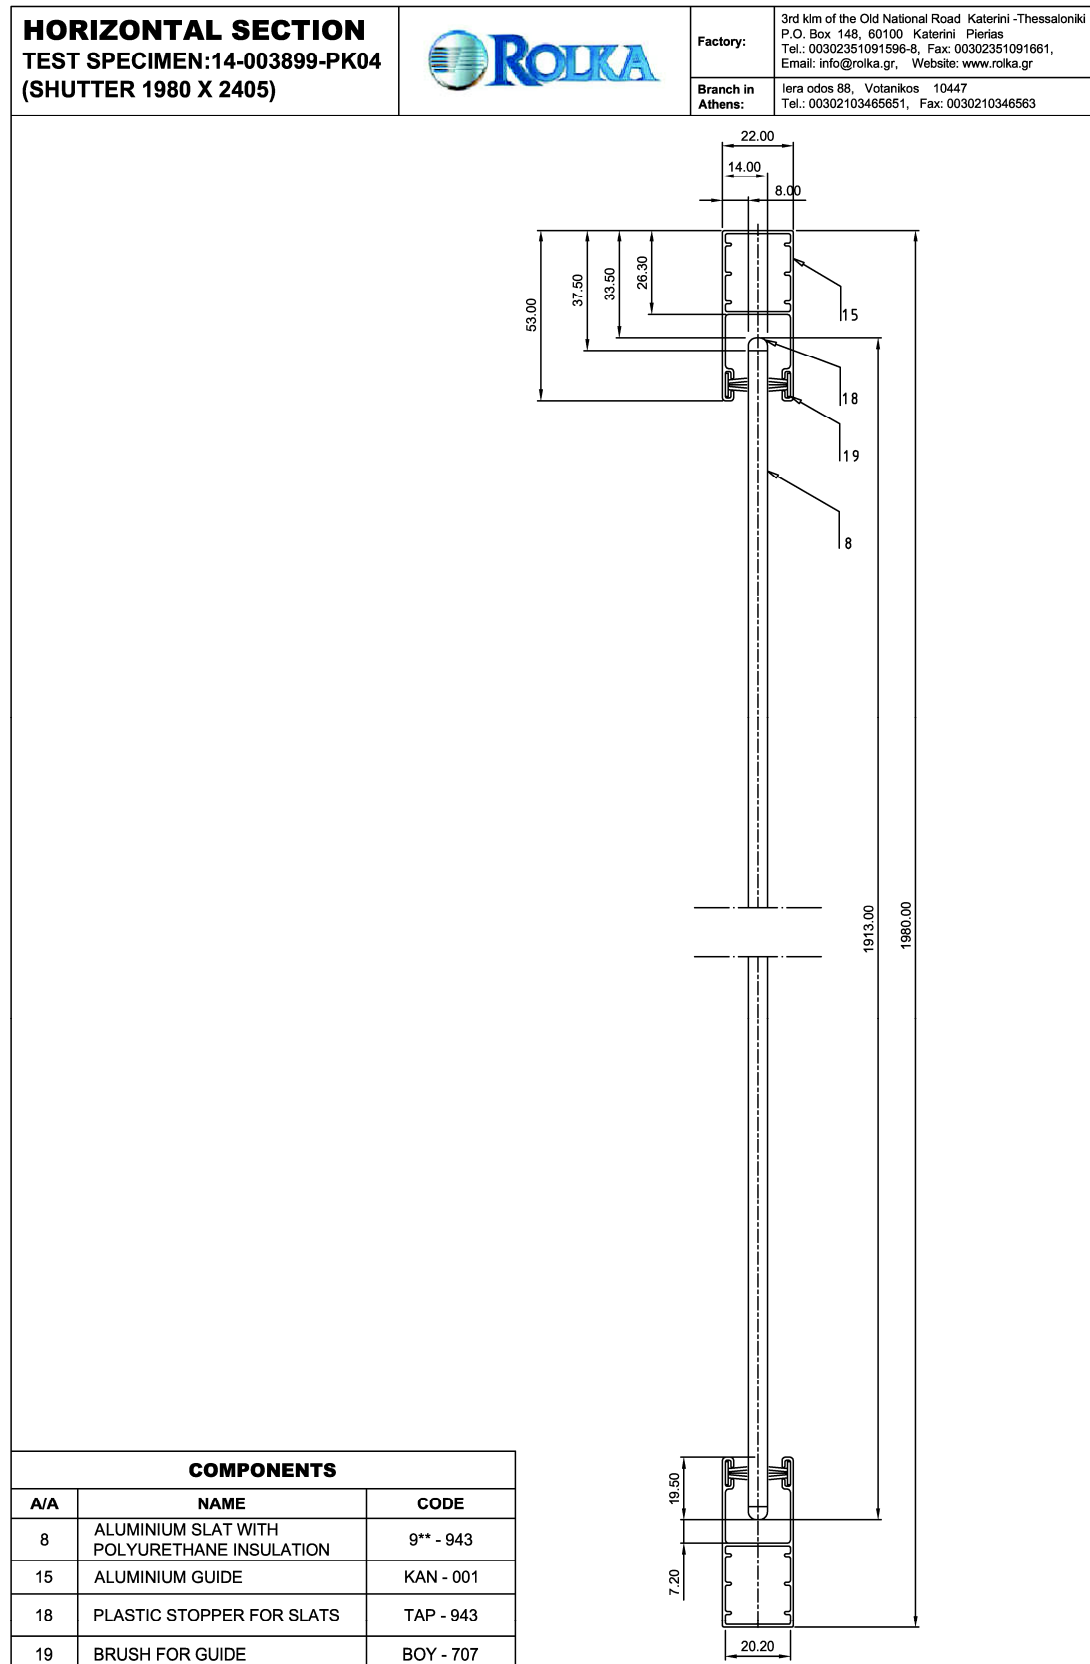
**Figure 2** Horizontal section

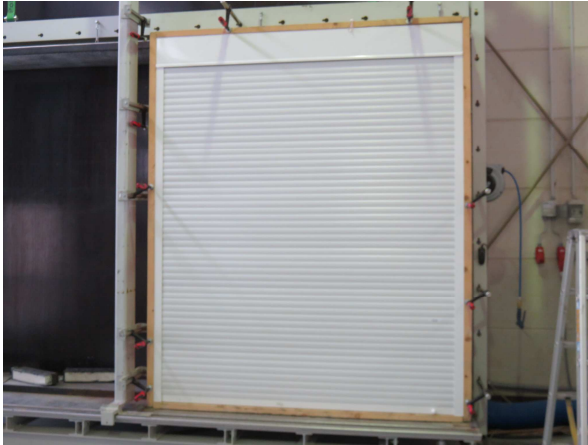
**Figure 3** Test specimen

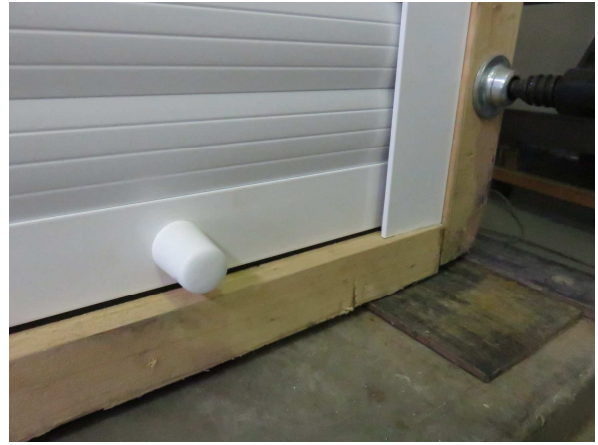
**Figure 4** Bottom lath and guide rail

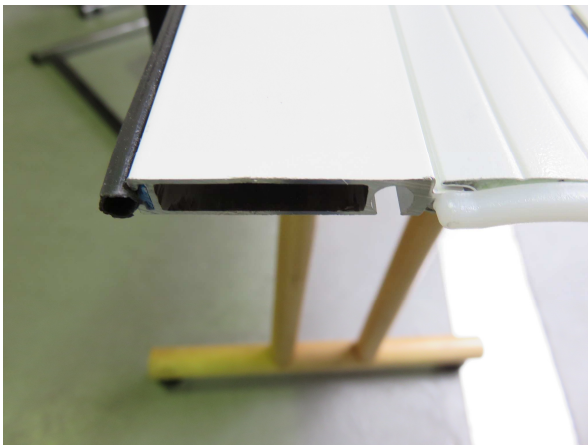
**Figure 5** Detail bottom lath

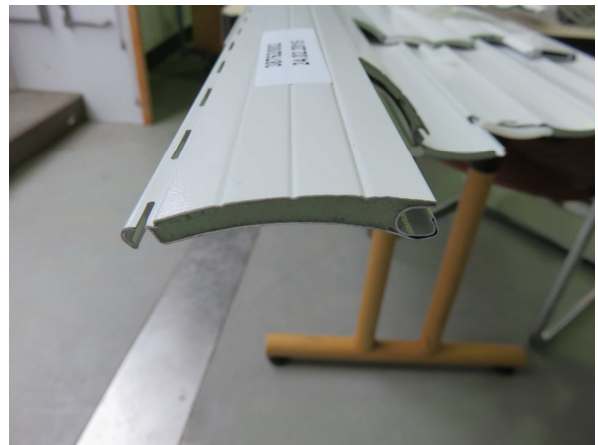
**Figure 6** Details of lath profile

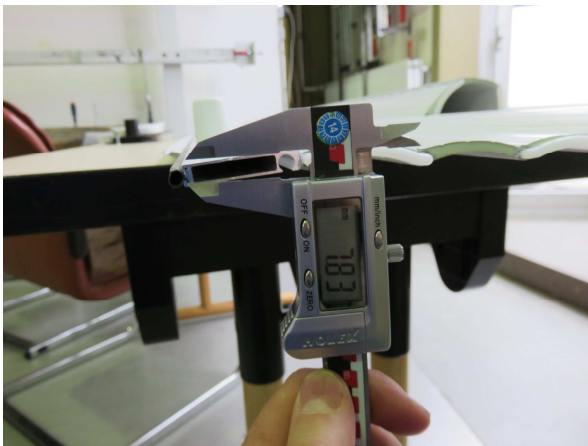
**Figure 7** Detail bottom lath and lath profile with slider

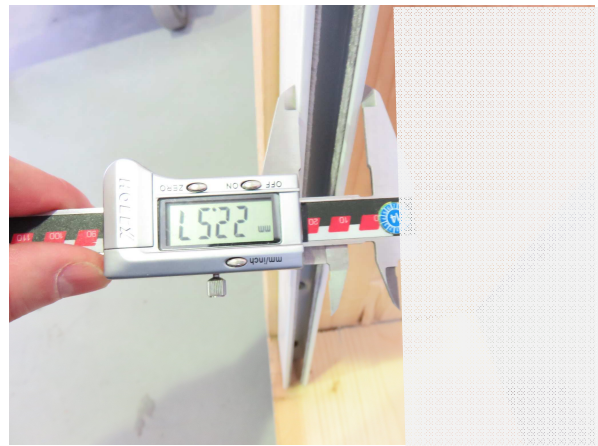
**Figure 8** Detail aluminium guide rail

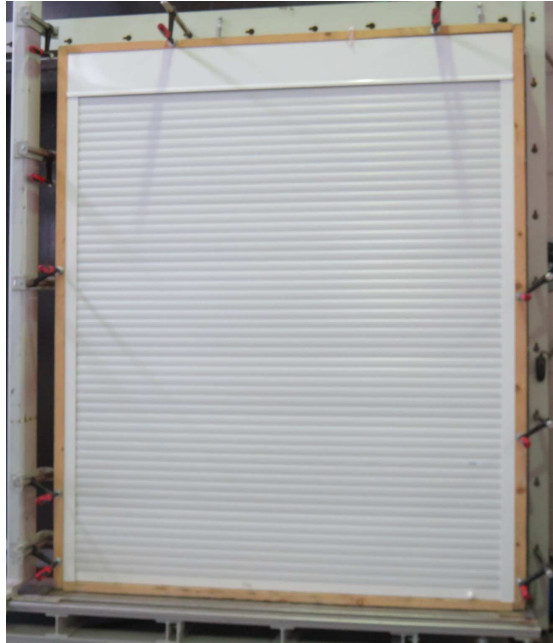
**Figure 9** Test wall

Figures 9 to 12 show the schematic test arrangement and the measurement points.

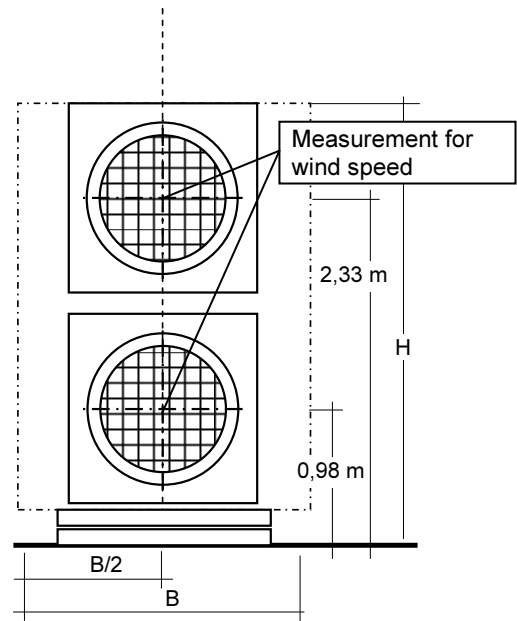
**Figure 10** Position of wind generators

The wind speeds generated were measured approx. 1.0 m respectively approx. 2.33 m above ground using a vane anemometer located at a distance of 1 m in front of the test specimen. The distance between the wind generators and the test specimen was 4.0 m.

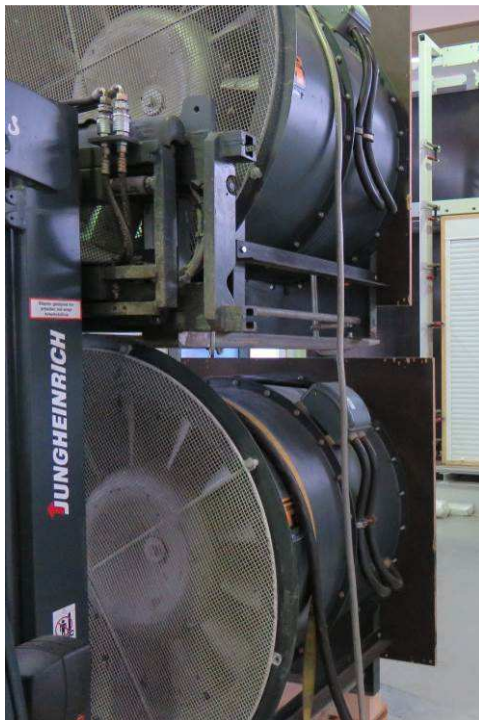
**Figure 11** Layout of wind generators

The test specimen was exposed to dynamic wind load provided by two wind generators (rotor diameter Ø 1 m) arranged one above the other. The wind load was adjusted by setting the speed of the wind generators to different wind velocities, see Table 1.

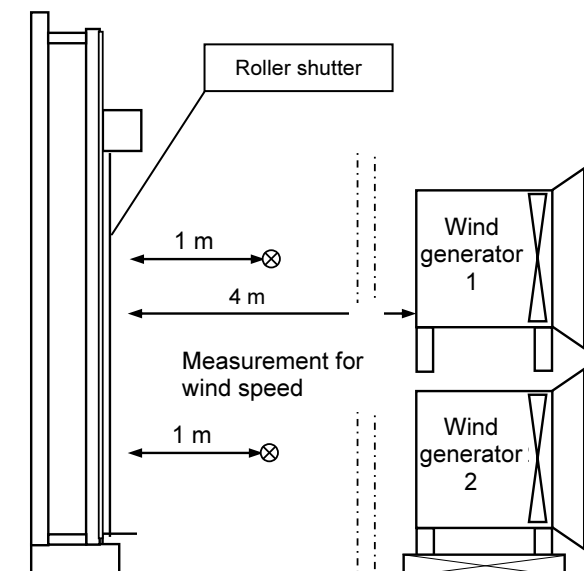
**Figure 12** Test configuration for dynamic wind load

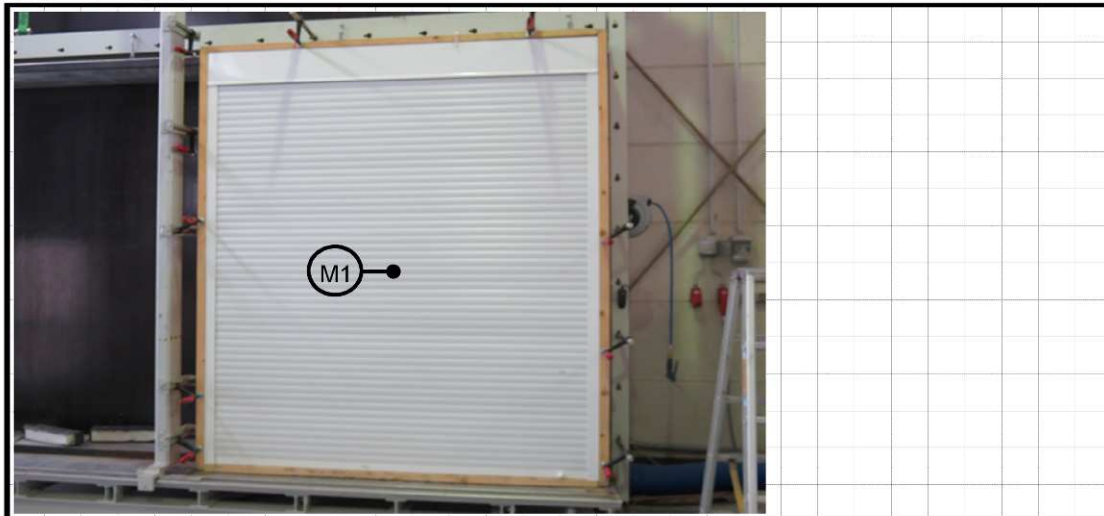
Seen from outside

**Photo 1** Test specimen

Measurement point of deflection

| Wind speed *) | | Deflection<br>mm | Observations |
|---|---|---|---|
| 20.0 m/s | 72 km/h | 31 | Slight rattling noise of box cover |
| 25.0 m/s | 90 km/h | 58 | Sliding out at approaching the wind speed |
| after load | | 0 | defect |
